# **Fluvial Geomorphology Assessment of Northern Connecticut River Tributaries**

## **Final Report**

Connecticut River Joint Commissions  
Charlestown, New Hampshire

Field Geology Services  
Farmington, ME

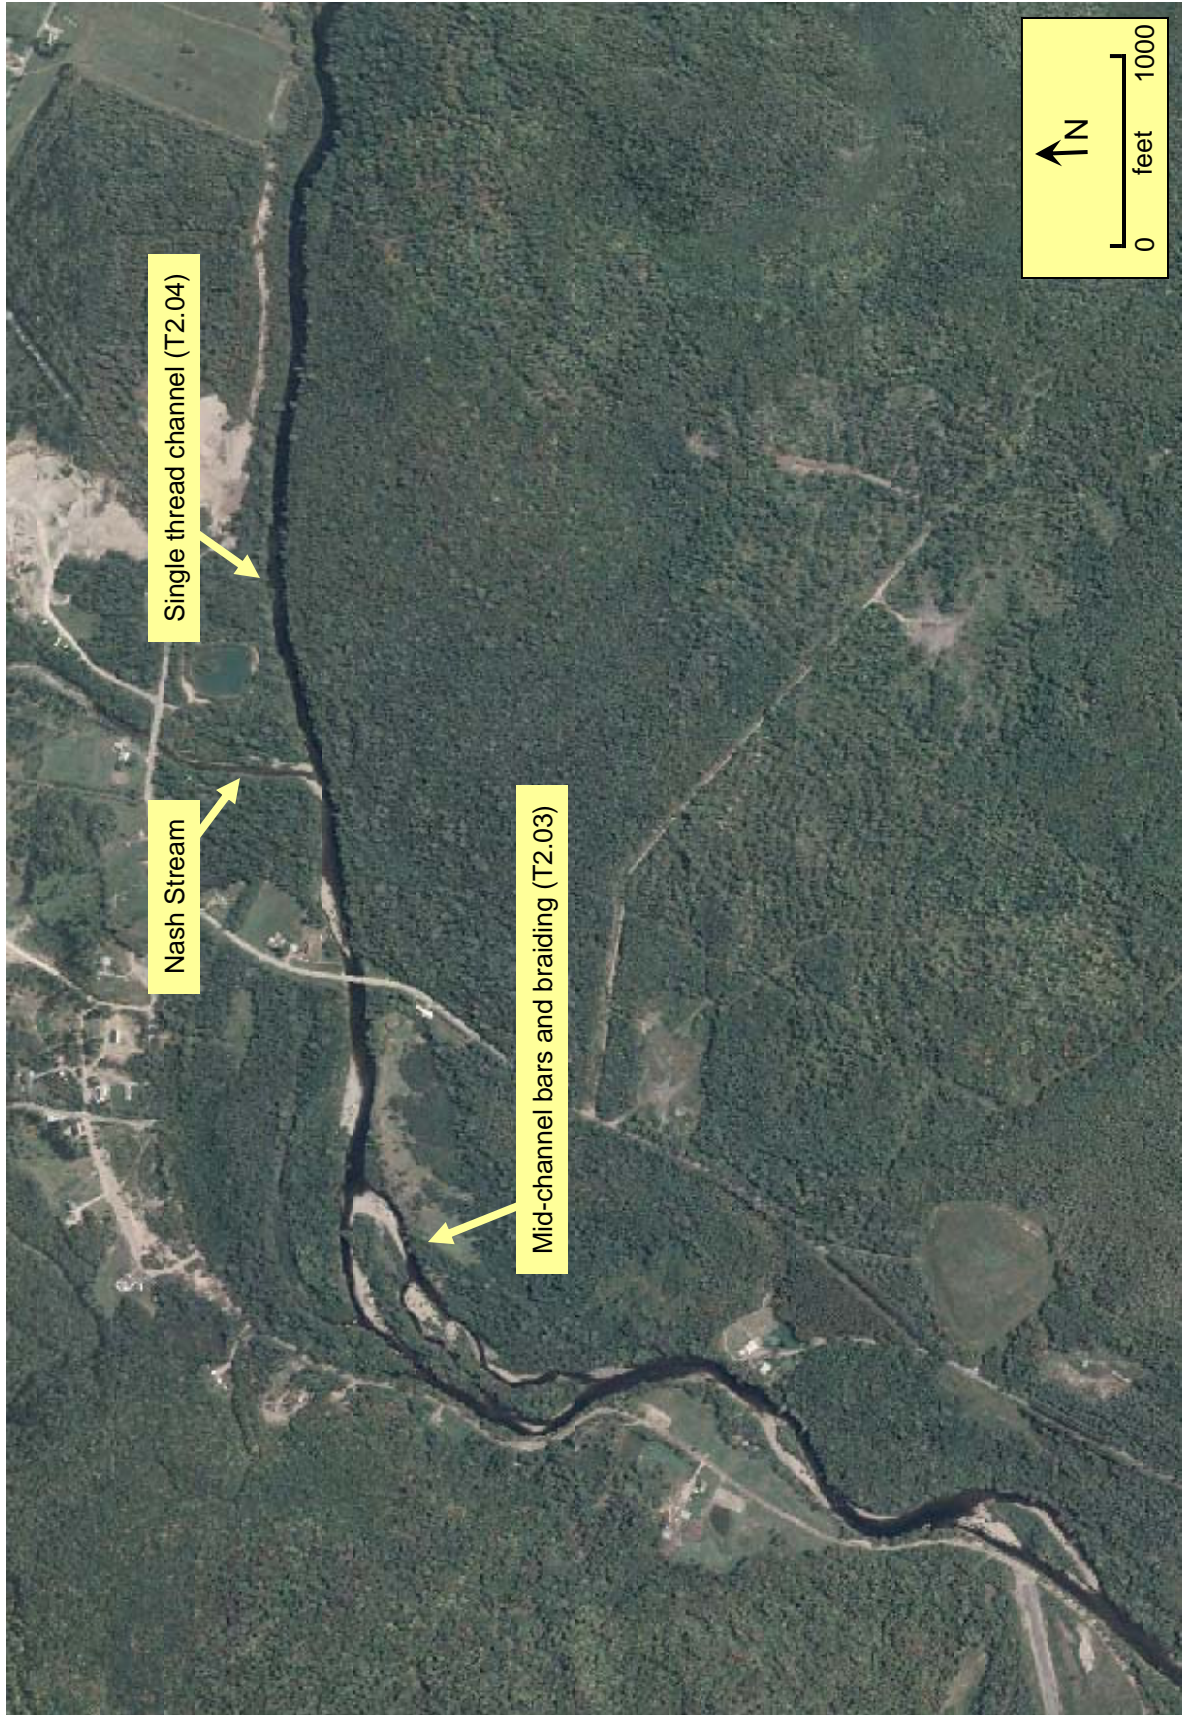
## Morphological Changes at the Nash Stream Confluence

Figure 4: Morphological changes at the Nash Stream confluence

Significant changes in channel morphology are evident at the confluence of Nash Stream (Reach Break T2.04) with large gravel bars and braided channels present downstream in Reach T2.03 while a narrow single thread channel is present upstream in Reach T2.04 (Figure 4). The remaining reach break is at the confluence with the Connecticut River (T2.01). No significant natural changes in valley slope occur along the length of the river, but three dams are found in Reach T2.02 and impound water for the total length of the reach (Figure 3b). Of the nine identified reaches, a Phase 2 assessment was completed on four (Table 2).

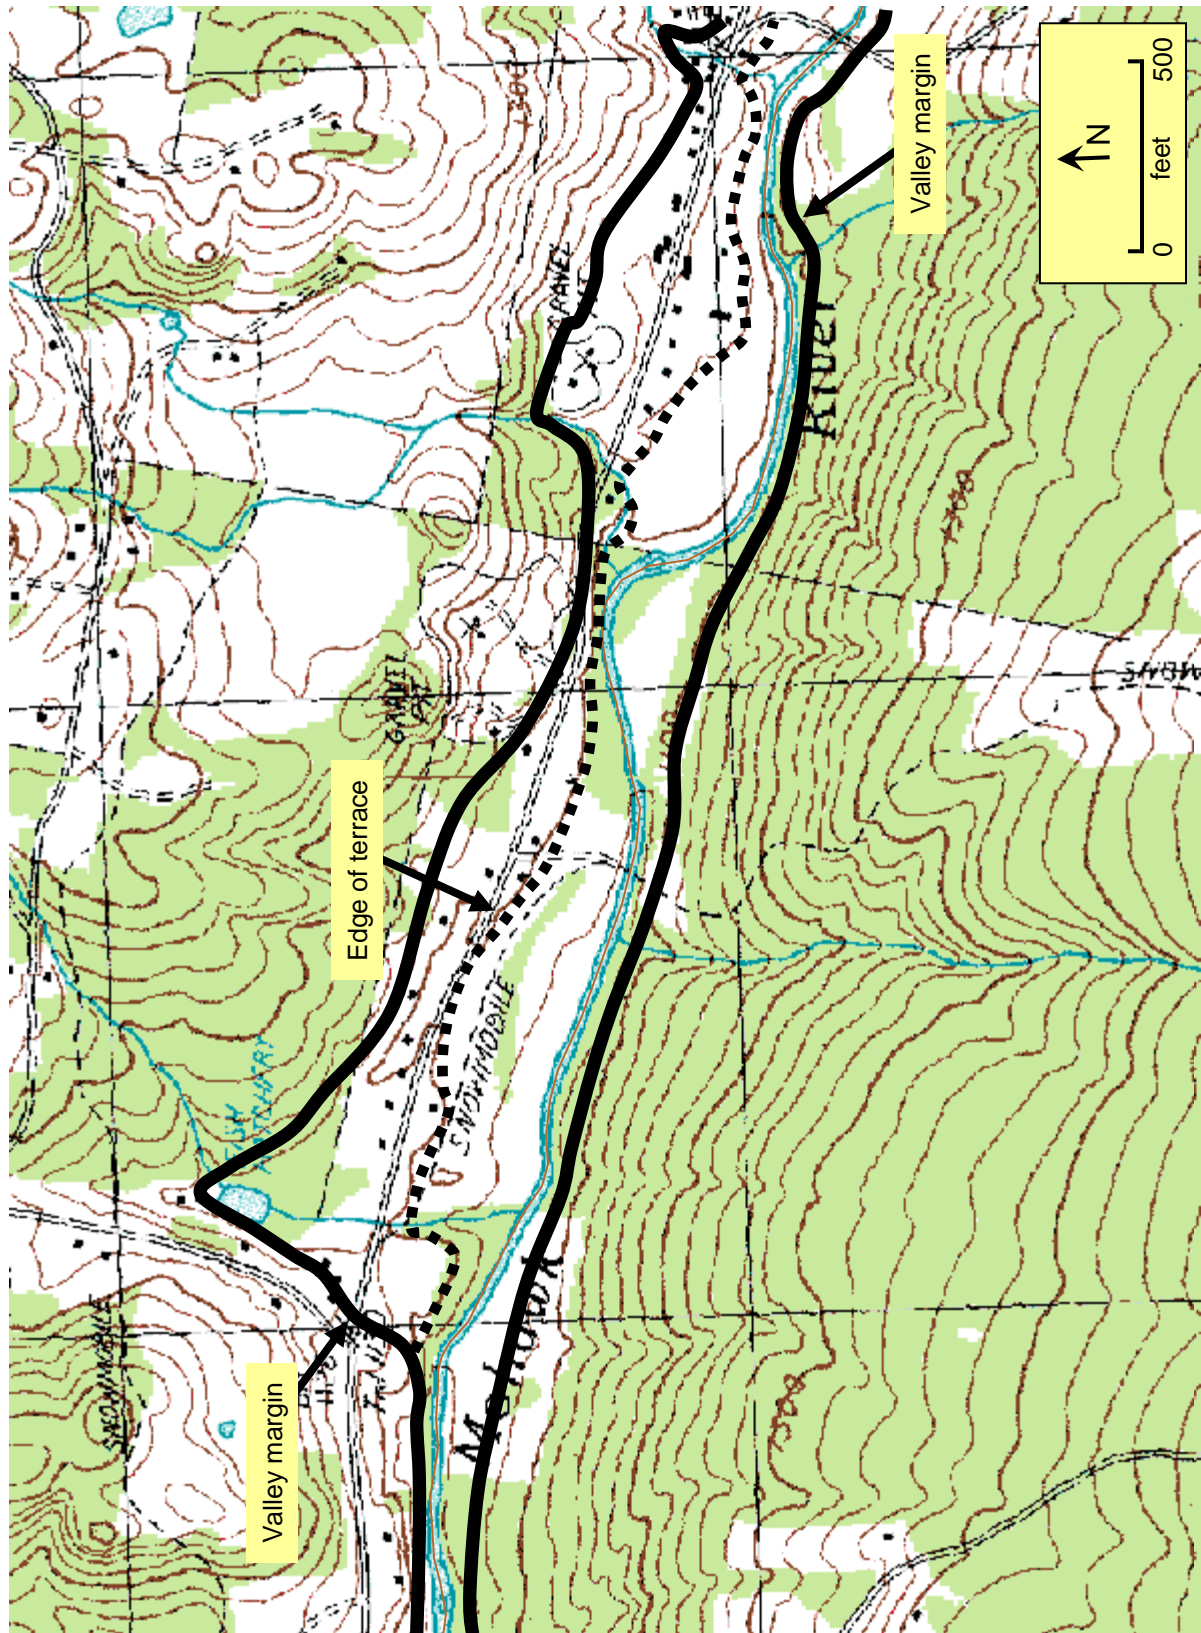
## Valley Confinement in the Mohawk River Valley (Reach T4.04)

Figure 5: a) Valley confinement on the Mohawk River and b) unconfined valley on the Upper Ammonoosuc River

Rivers flowing through broad valleys typically have lower slopes, higher natural channel sinuosities, and greater rates of channel migration than those in more confined valley segments. The Mohawk River is generally more confined between bedrock and glacial outwash terraces while several reaches on the Upper Ammonoosuc River flow across a broad floodplain (Figure 5; Table 3; Appendix 1). Consequently, Mohawk River sinuosities are naturally less than 1.2 on all but the unconfined alluvial fan (as determined by the ratio of channel length/valley length) but exceed 1.7 in Reach T2.07 on the Upper Ammonoosuc, the only unconfined reach with limited human channel manipulation (Figure 5; Table 3; Appendix 1). Broad unconfined reaches with shallow slopes, marshy areas, and high sinuosities are a consequence of glacial erosion (Figure 5b). Glaciers and ice sheets are capable of scouring flat valleys that become highly meandering depositional zones as the river tries to achieve a more graded slope. Narrower valley segments on the Upper Ammonoosuc are generally confined by bedrock as at Devil's Slide in Stark (Reach T2.06; Figure 6a) but Reach T2.04 is unusual in that the northern valley wall is confined by ancient alluvial fan deposits of Nash Stream (Figure 6b). Overall, valley widths are much narrower on the Mohawk River and valley gradients much higher compared to the Upper Ammonoosuc (Table 3 and Appendix 1). While these differences are largely the result of the underlying bedrock geology, the Mohawk River Valley is further confined by glacial outwash terraces inset within the bedrock ridges (Figure 5a).

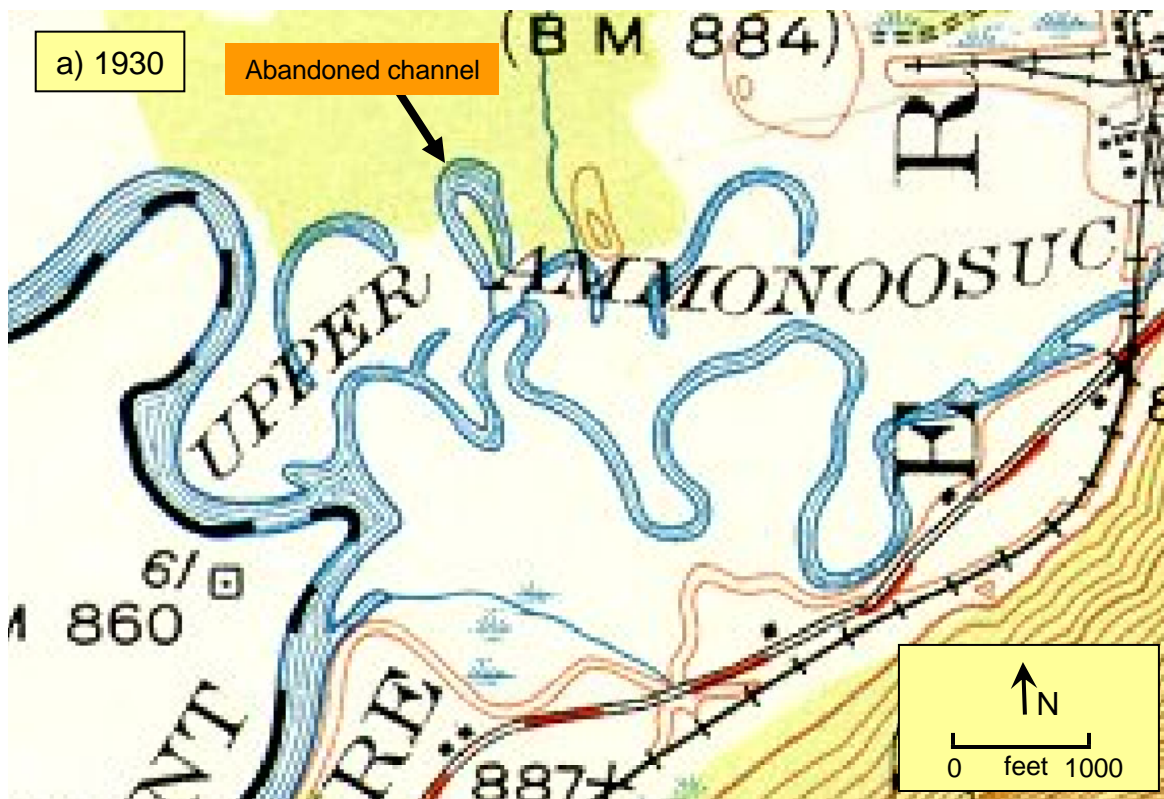
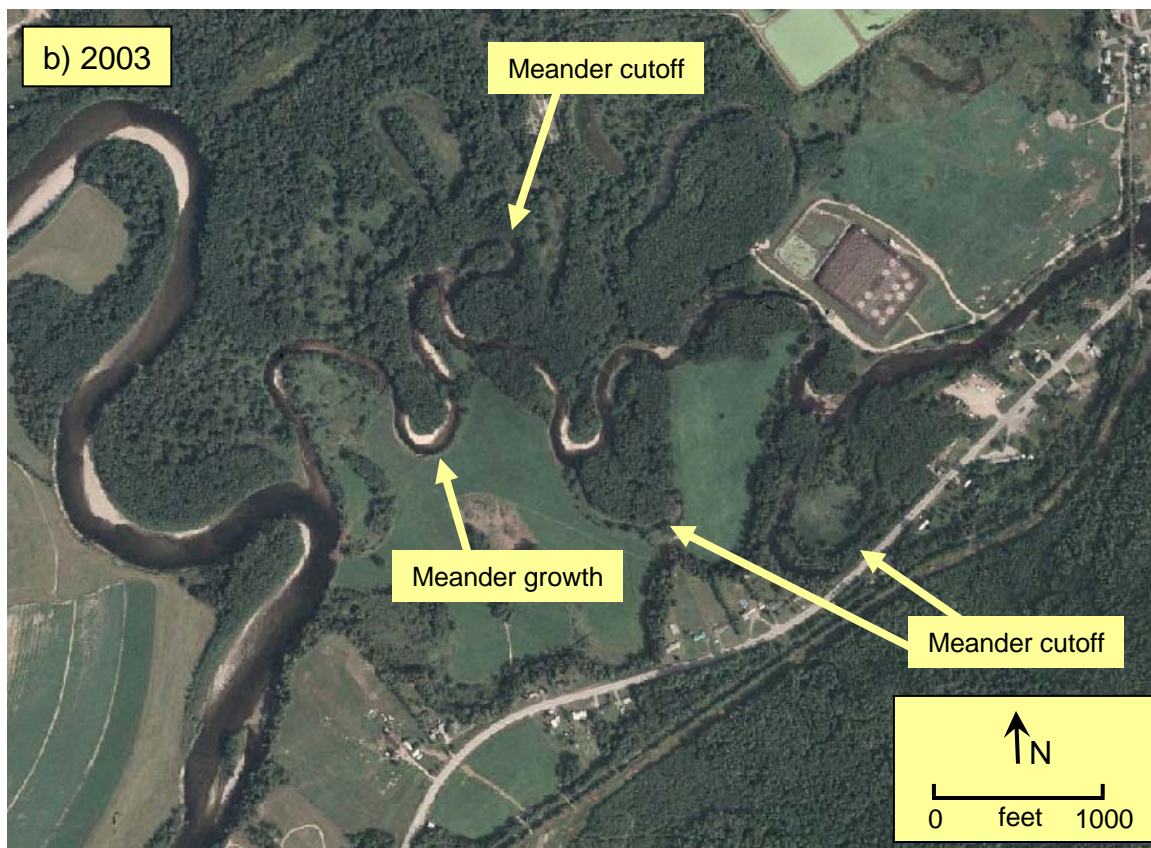
## Channel Changes on the Upper Ammonoosuc (Reach T2.01)

Figure 7: Channel changes on the Upper Ammonoosuc River between a) 1930 and b) 2003

Downstream of Weston Dam, bank erosion of very loose alluvial fan gravels is observed along both banks (Figure 12). While the erosion may be the result of a sediment deficit below the dams, the possibility that the bank instability is the result of channel straightening cannot be discounted (see Section 3.2 above). The presence of large unvegetated sand bars further downstream in Reach T2.01 near the confluence with the Connecticut River suggests that any sediment deficit below the dam does not persist for any great distance downstream (Figures 7b and 10a).

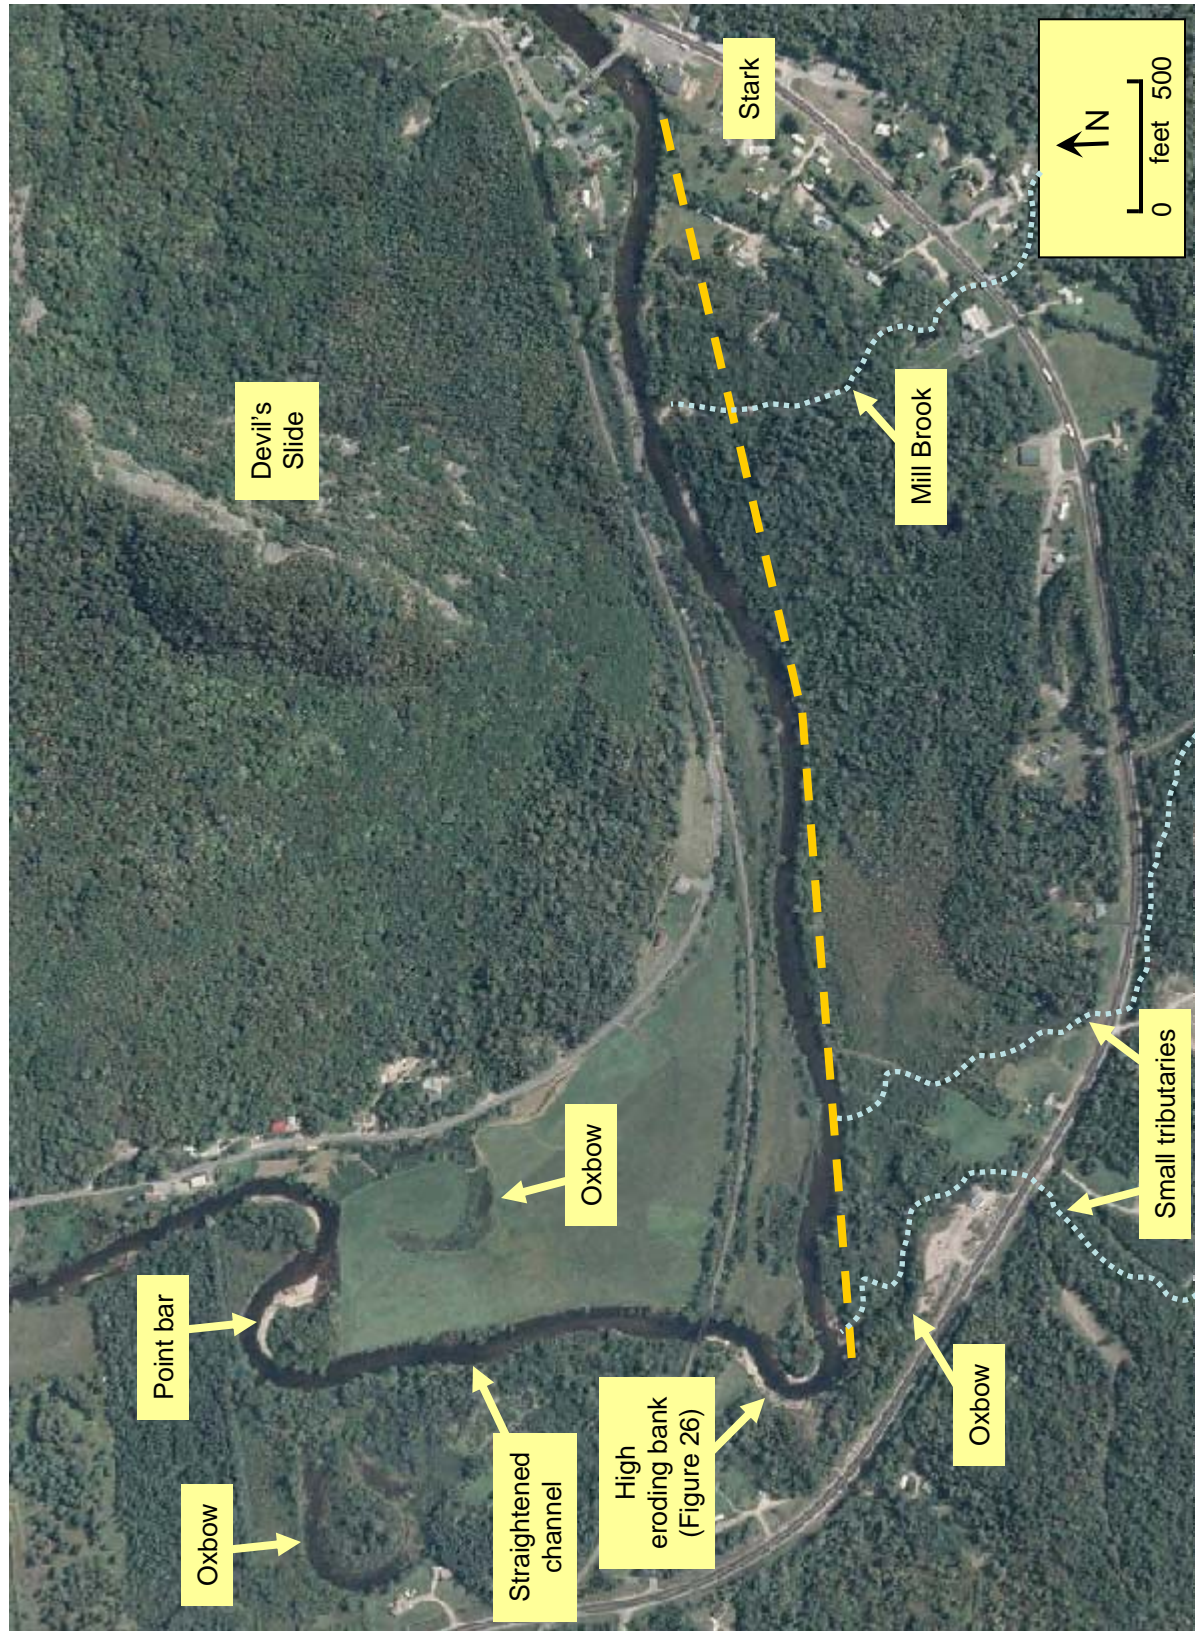
## Channel Straightening on the Upper Ammonoosuc (Reach T2.05)

Figure 8: Channel straightening on the Upper Ammonoosuc River and resulting channel responses

Note: Dashed orange line represents original position of channel immediately after straightening

Elsewhere on the Upper Ammonoosuc River, tributary inputs are responsible for recreating meanders on previously straightened channel segments (Figure 8). As sediment is deposited at the mouth of the tributary, flow on the Upper Ammonoosuc is deflected into the opposite bank. Erosive pressures on the opposite bank lead to bank instabilities and bank armoring if infrastructure is threatened as at the Mill Brook confluence (Figure 17). The amount of channel migration resulting from this process appears to be related to the size of the tributary responsible for sediment inputs. Mill Brook has shifted over 250 feet from the position of the channel immediately after straightening while the smaller tributaries to the west have migrated less than 100 feet (Figure 8).

Sediment production from tributaries is high in the Upper Ammonoosuc watershed with Nash Stream completely transforming the morphology of the channel upstream and downstream of the confluence (Figures 4 and 16). Channel migration in each reach downstream of the Nash Stream confluence is driven by the sediment delivered to the Upper Ammonoosuc (Figures 7, 11, and 14). As with the 1929 dam break flood on the Mohawk River, the 1969 dam break flood on Nash Stream destabilized several high banks of glacial outwash deposits that continue to contribute sediment to the stream over 35 years after the flood. Berming and straightening completed after the flood to protect roads along Nash Stream have constricted flows in the channel such that the base of the high banks are frequently scoured and the banks are unable to stabilize. Tributary inputs from other streams are also high. Sediment from the tributaries is what drives the recreation of meanders along previously straightened segments and creates instabilities that are transferred downstream (Figures 8 and 17).

In contrast to the Mohawk River, conditions on the Upper Ammonoosuc tend to limit sediment delivery to the Connecticut River. Although sediment delivery is high through straightened (Figure 8) and armored reaches (13 percent of the banks are riprapped), many natural meandering sections remain on the Upper Ammonoosuc, especially at the confluence (Figure 3b). Sediment stored on point bars within the meander bends (Figures 7, 8, and 10) and mid channel bars in braided sections (Figures 11 and 14) limits sediment delivery and ameliorates impacts to the Connecticut River. Sediment does reach the Connecticut River during high discharges, but the sand bar on the Connecticut River below the confluence has diminished in size since 1970 – a period with no large floods (Field, 2006). In contrast, the mid channel bar downstream of the Mohawk River confluence has grown in size during the same time period (Figure 9).

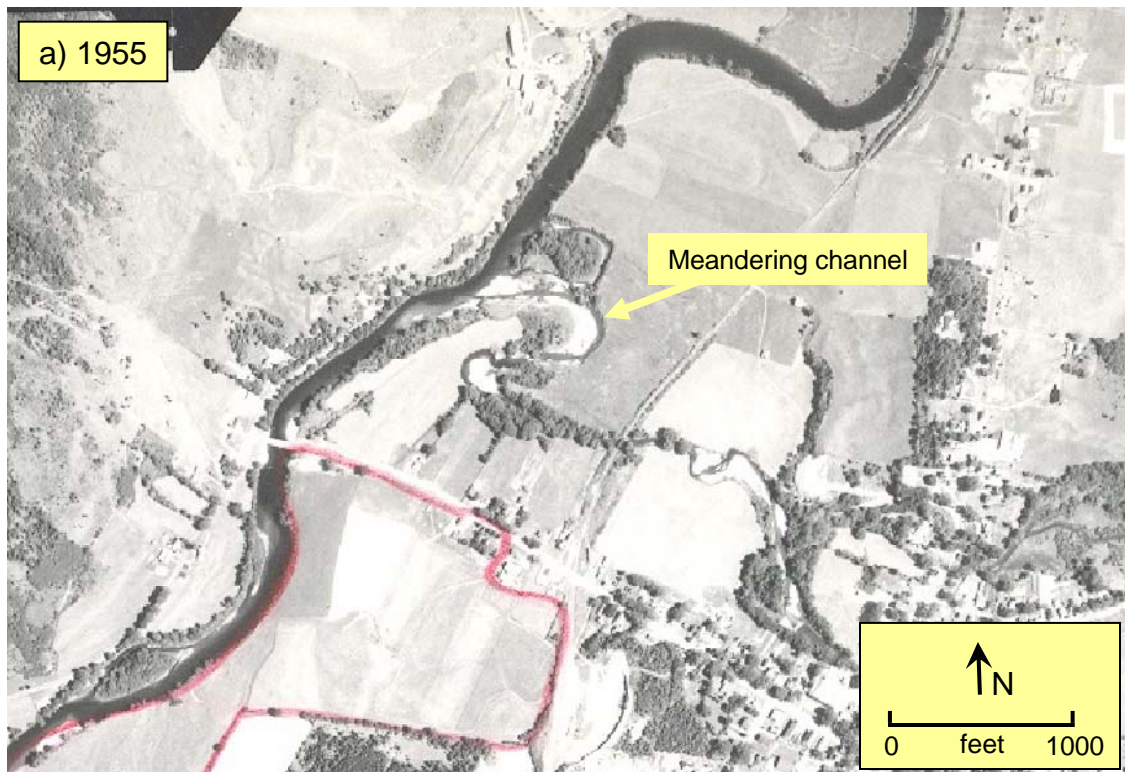
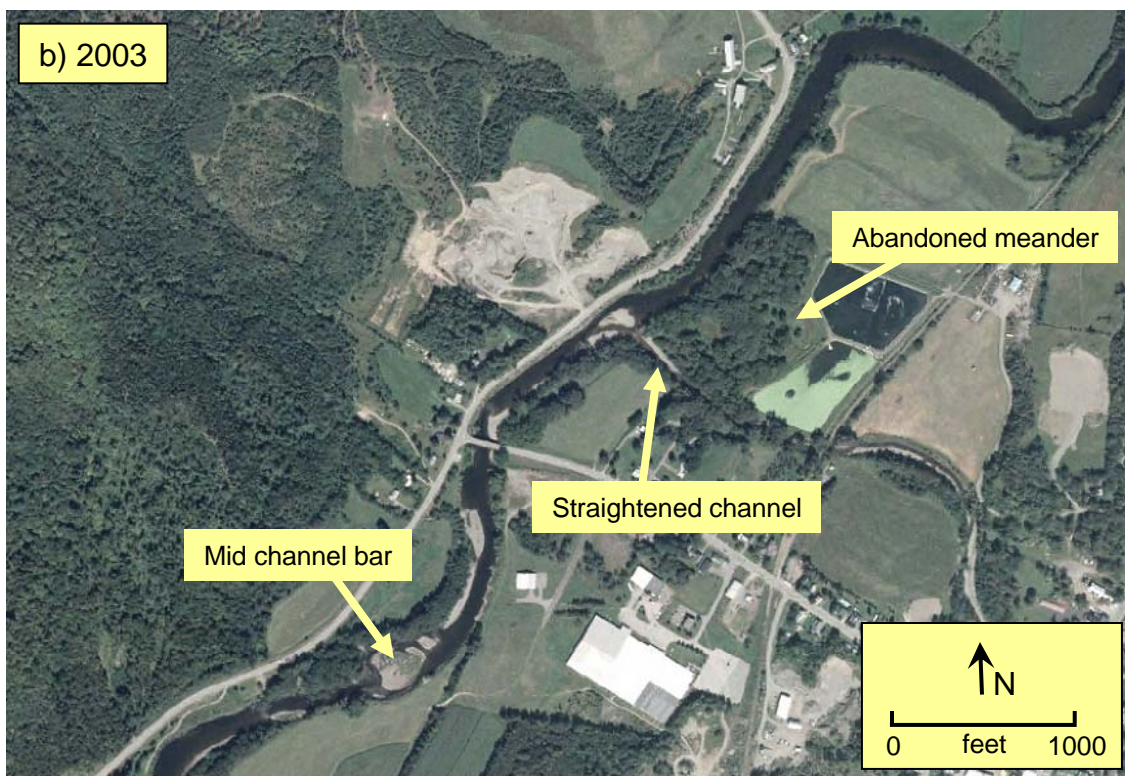
## Evidence for Channel Straightening in the 1960's on the lower Mohawk River (Reach T4.01)

Figure 9: Channel straightening on the lower Mohawk River between a) 1955 and b) 2003

Note: Channel position is unchanged between 1970 and 2003 aerial photographs

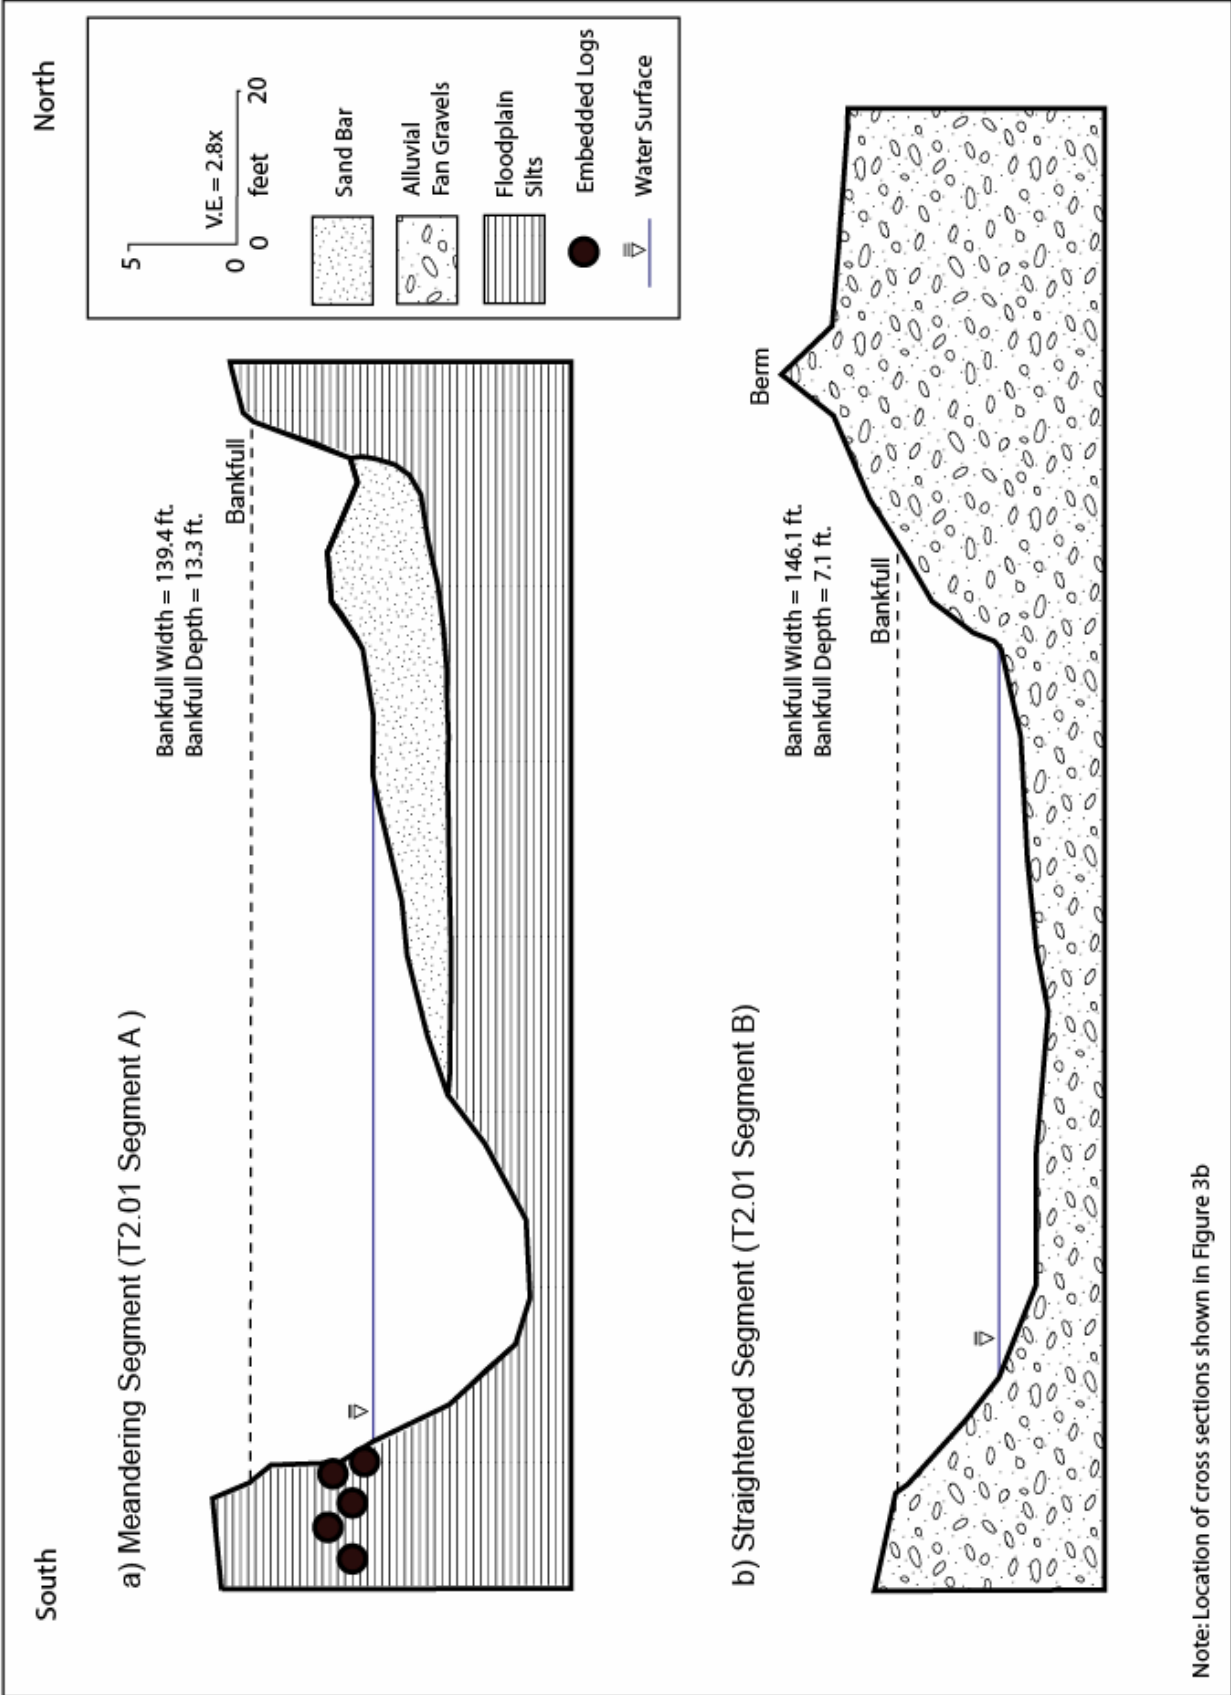
# Comparison of Upper Ammonoosuc Cross Sections

Figure 10: Cross section comparison of a) a meandering segment and b) a straightened segment

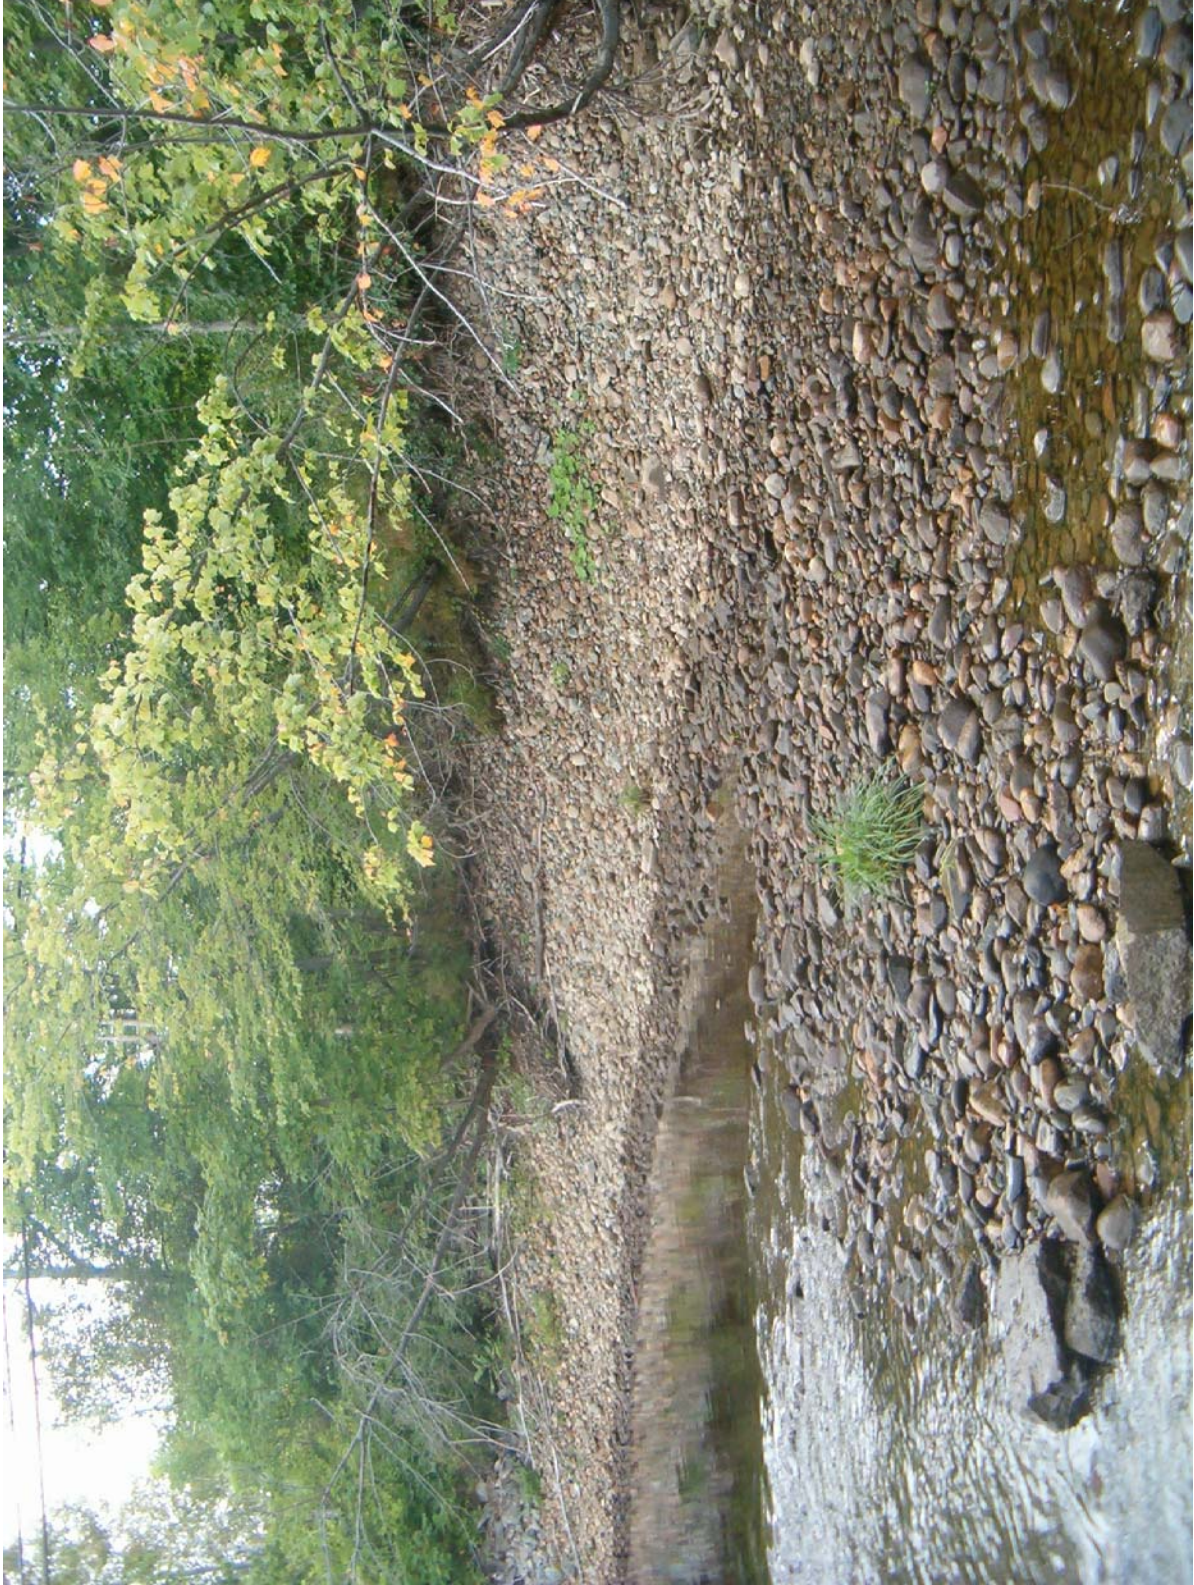
## Erosion of Alluvial Fan Gravels (Reach T2.01)

Figure 12: Erosion of alluvial fan gravels on the Upper Ammonoosuc River

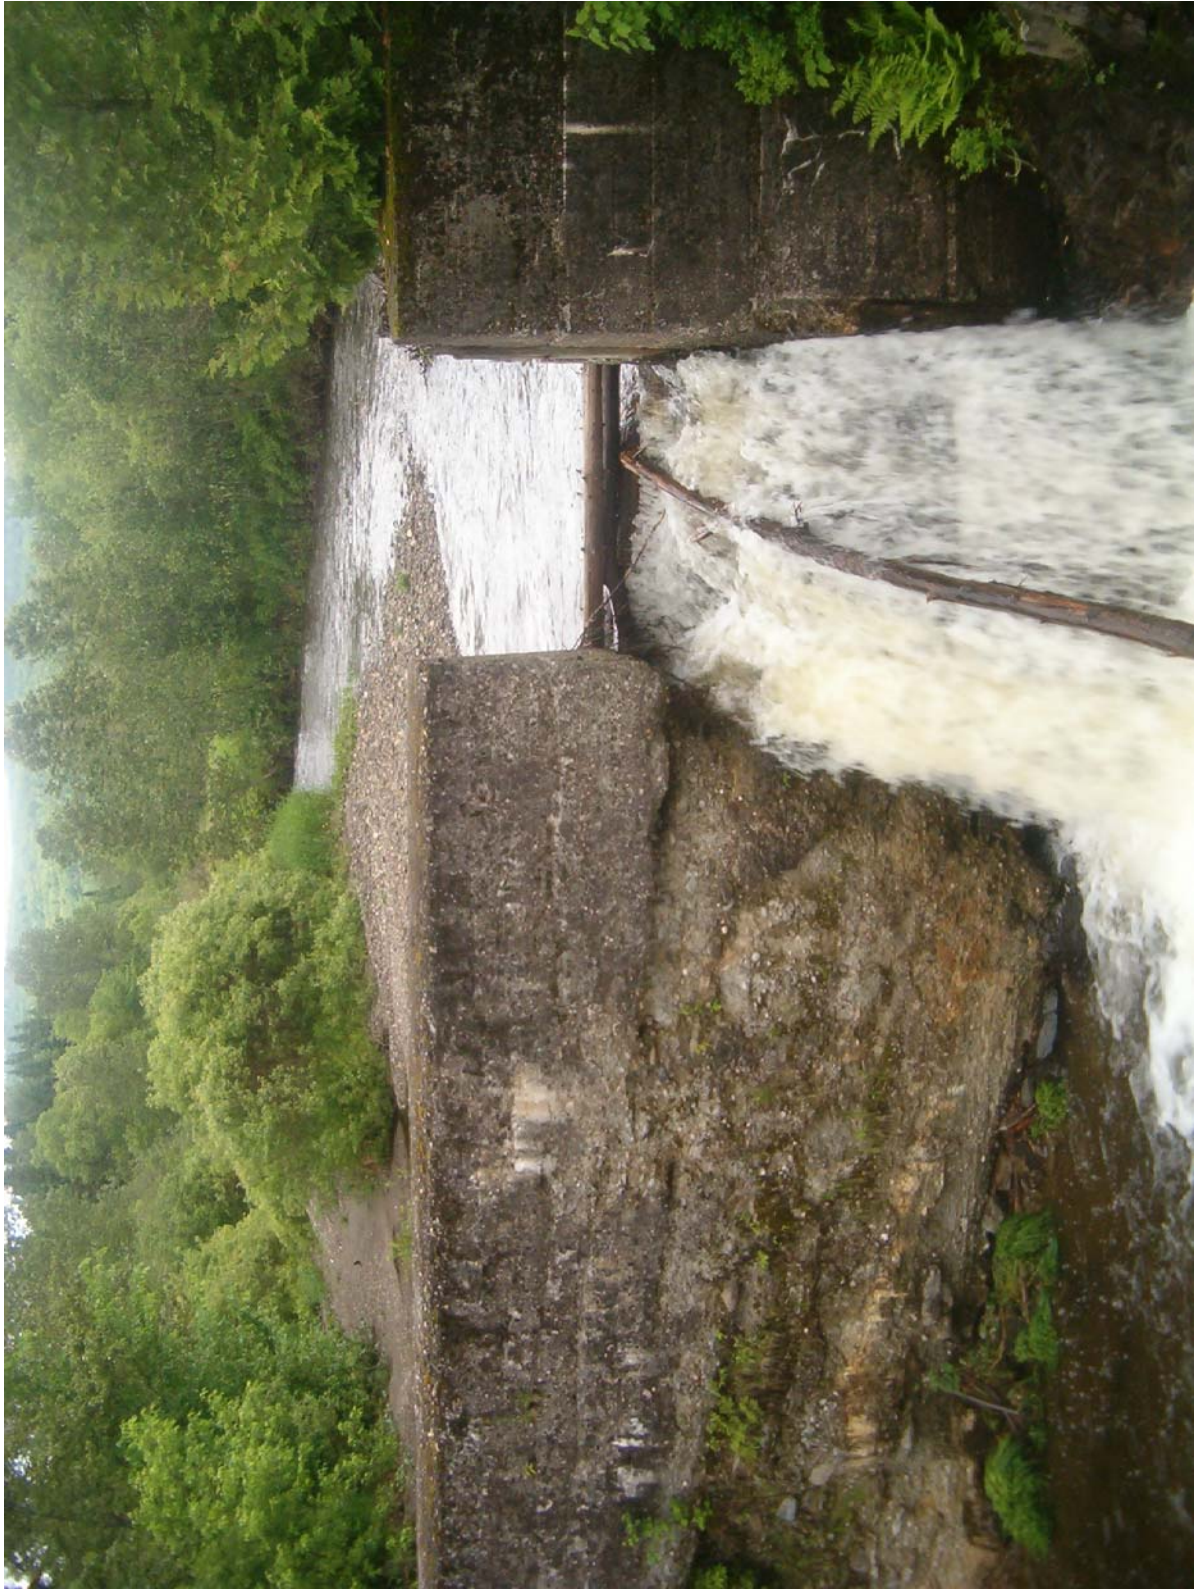
Sediment Accumulation behind the Breached Washburn Mill Dam (Reach T4.06)

Figure 13: Sediment accumulation behind the breached Washburn Mill Dam

In addition to the existing dams, a number of other dams were once present on both rivers and are currently in various states of disrepair (Figure 13; Appendix 3). Some that are only partially breached, such as the Washburn Mill Dam on the Mohawk River, have large mid channel bars formed behind them (Figure 13). Mid channel bars also persist in locations where dams are now completely absent, but the dams might be responsible for the initial bar formation (Figure 14a). One dam in each watershed failed catastrophically and resulted in large floods that had dramatic morphological impacts on the channel as discussed in Section 3.6 below.

However, the cumulative effect of small amounts of sediment derived from 25 percent of the river's length could also lead to excessive sedimentation at the river's mouth. Although tributaries were not seen to greatly impact the river's morphology, some sediment is also derived from the numerous small tributaries that enter the Mohawk River from the north and south (Figure 2a). Finally, sediment impounded behind breached dams would become another source of inputs to the Connecticut River if the dams deteriorate further (Figure 13).

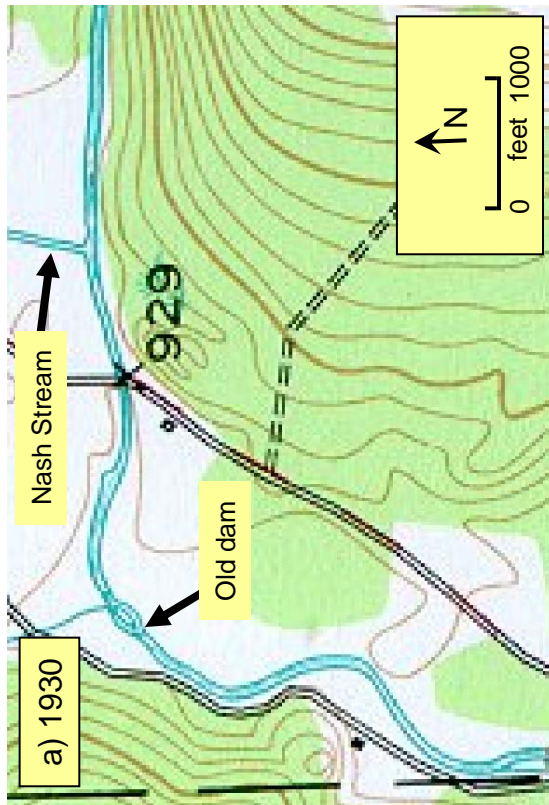
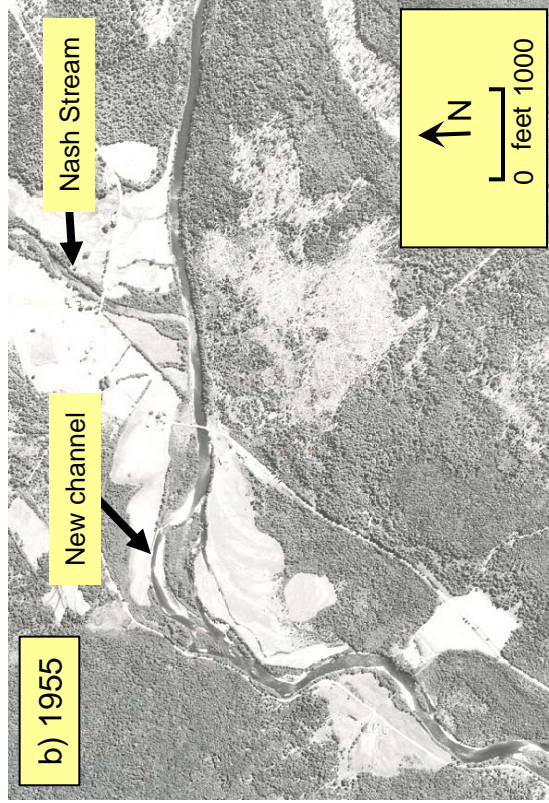
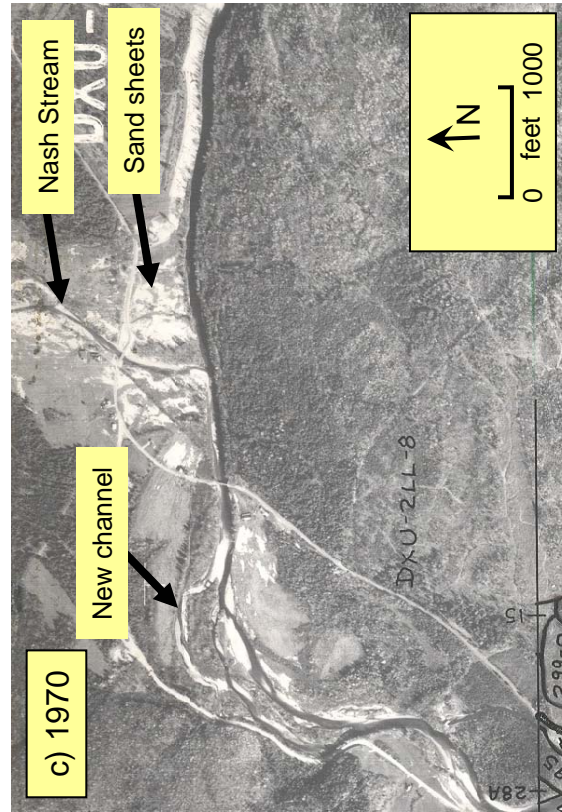
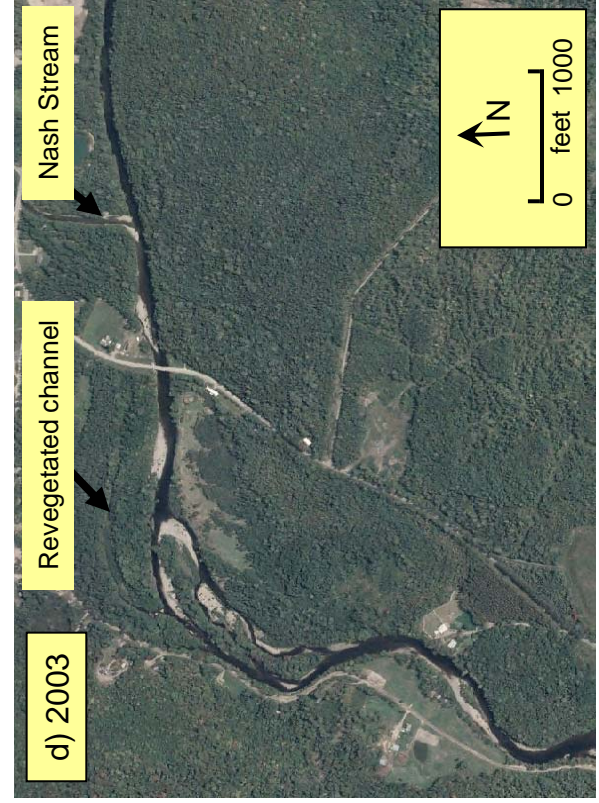
# Channel Changes Downstream of Nash Stream (Reach T2.03)

Figure 14: Channel changes downstream of Nash Stream between a) 1930, b) 1955, c) 1970, and d) 2003

Note: New channel and revegetated channel are at same location in each photo

The tributary impacts on channel morphology discussed above are ultimately the result of large flow events capable of transporting sediment to the stream's confluence. The Upper Ammonoosuc downstream of Nash Stream was transformed from a single thread channel to a braided channel with large mid channel bars between 1930 and 1955, perhaps during the 1936 flood event (Figure 14a-b). The only mid channel bar on the 1930 map is at the location of an old dam no longer present (Figure 14a). The 1936 flood probably reopened a number of side channels that already existed prior to the flood but were not visible when the 1930 map was surveyed due to revegetation that occurred during several years with no large floods. The braided channel configuration below Nash Stream was further enhanced by another large flood in 1969 caused by the breaching of the Nash Stream Bog Dam (Figure 2b). Sand sheets deposited on the Nash Stream alluvial fan during the dam break flood are clearly visible on the 1970 aerial photograph, but the channel configuration downstream on the Upper Ammonoosuc remained relatively unchanged from 1955 (Figure 14b-c). No significant floods of comparable magnitude have occurred since 1969 and a number of side channels have consequently become revegetated (Figure 14d).

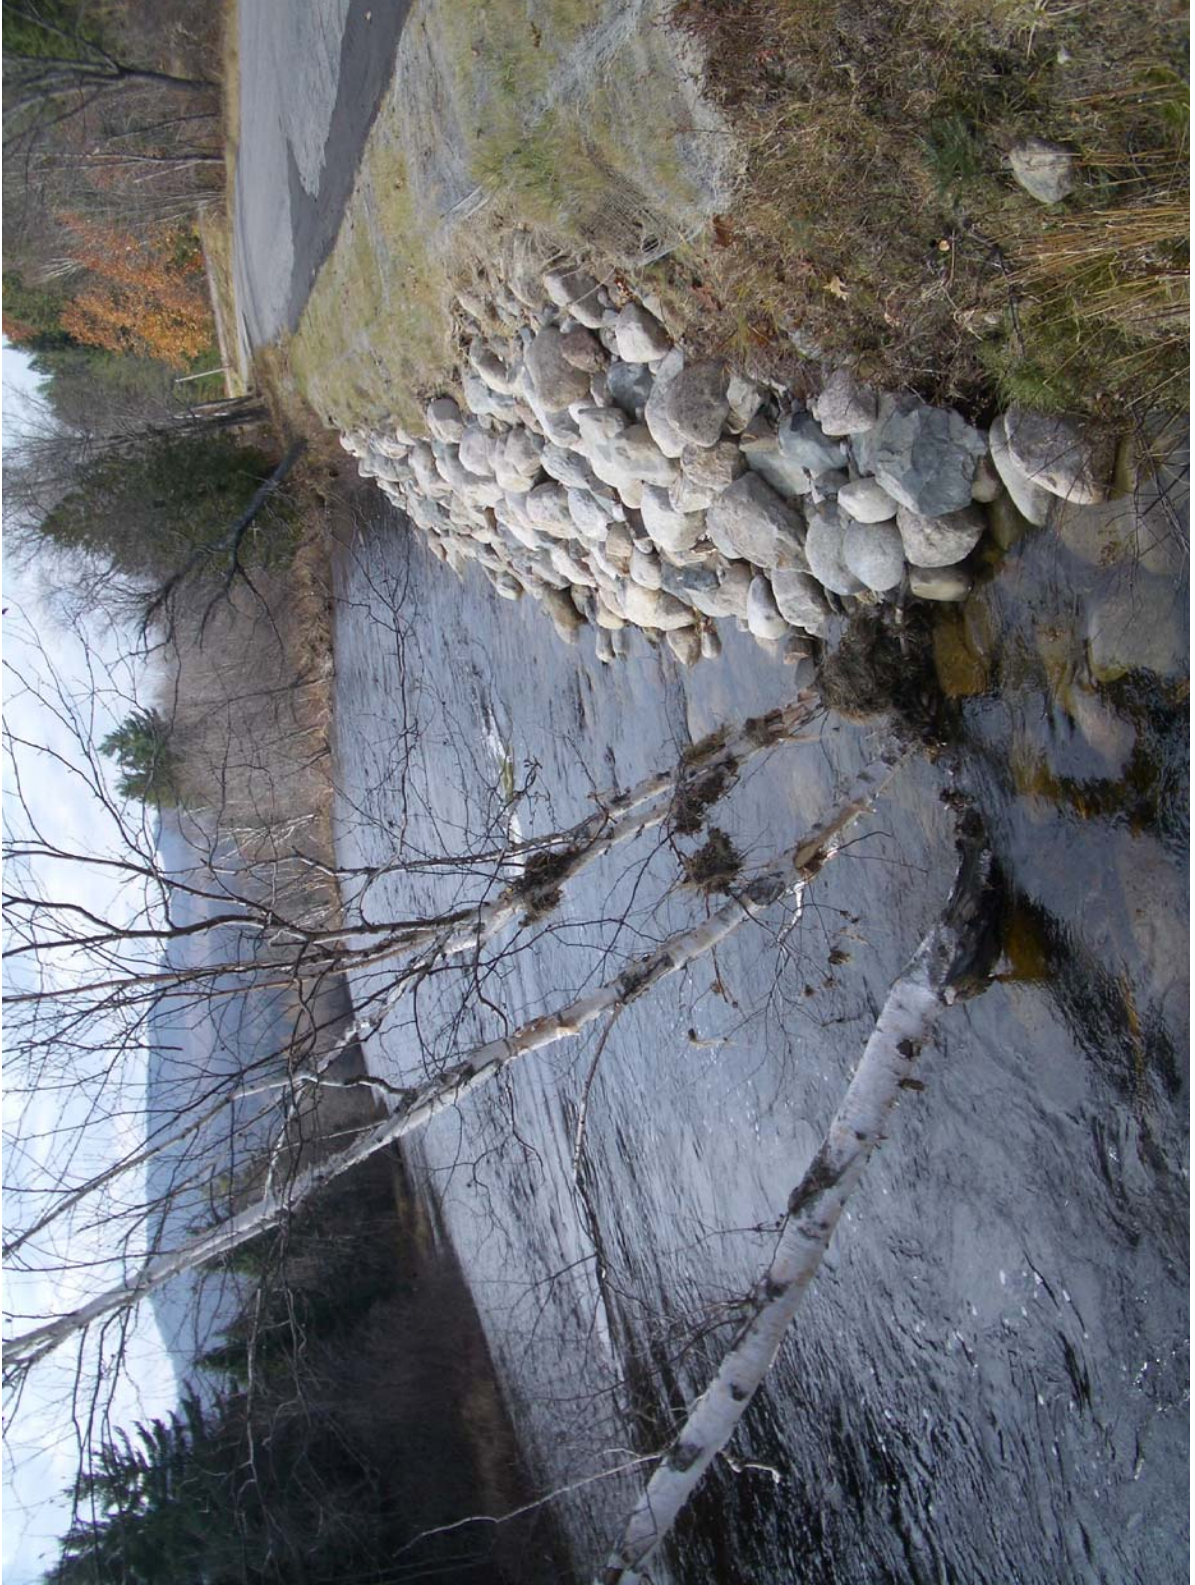
## Bank Armoring at the Mill Brook Confluence (Reach T2.05)

Figure 17: Bank armoring at the Mill Brook confluence

Note: View looking downstream on the Upper Ammonoosuc (Mill Brook out of view to the left)
